COVER SHEET

FLESHMAN CONSTRUCTION INSPECTORS

MESSAGE: A single item inspection was performed at 1226 Northwind Cir Bellingham, WA per request of the occupants that have been concerned with water intrusion to the underfloor areas and possible connections to indoor air quality inside the home. The inspection was performed following a rain event. The adjacent grounds surrounding the home were found to be heavily saturated including the water meter and irrigation junction boxes, the storm drain at the road did not appear overwhelmed. Significant amount of standing water observed at the under floor areas, more than what is considered to be a typical amount even after a period of heavy rainfall. This could be a high water table, spring or other condition that may not be feasible to correct. Strongly recommend further evaluation by a drainage professional and an indoor air quality professional.

1226 Northwind Cir Bellingham, WA

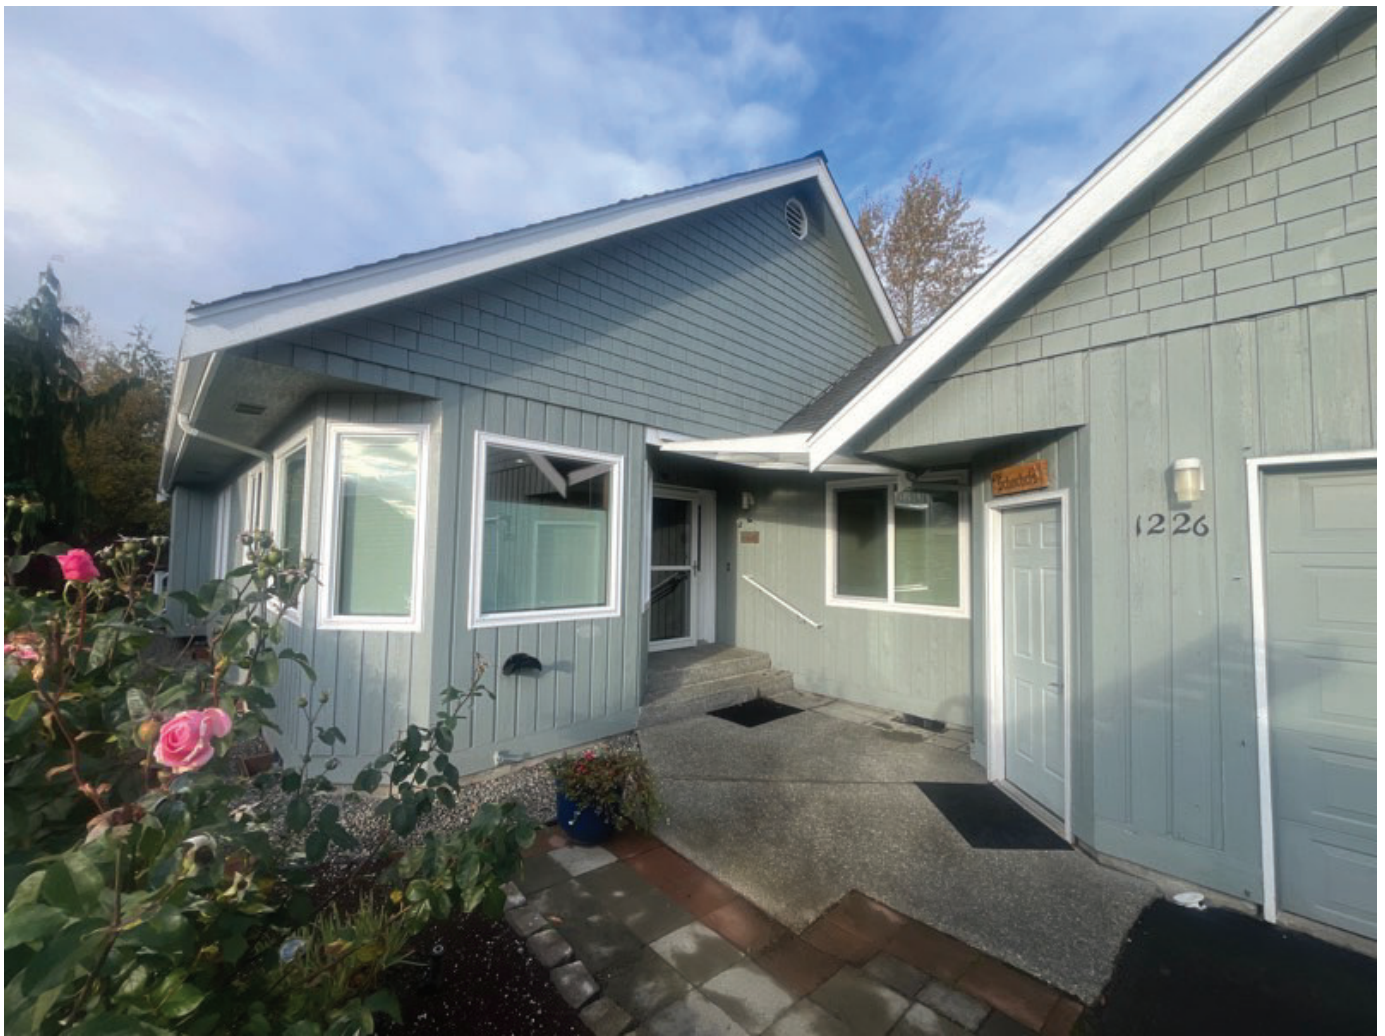
Saturation evident at north side of yard notably at the adjacent home walkway where standing water was visible

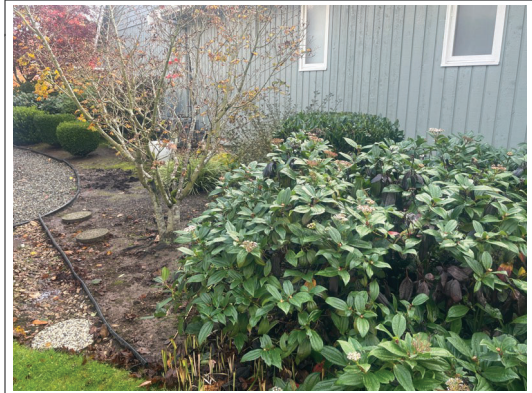
Saturation evident at the grassy area at the corner of the back patio deck, walking in this area produced indents in the ground that filled with water

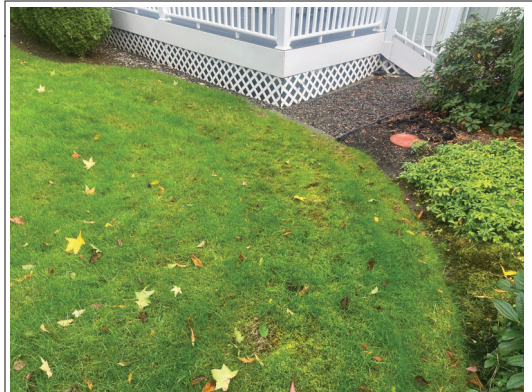
Negative slope observed in some areas around the building. There should be adequate slopes of the land and ground around a property. The slopes of the ground should be directed toward appropriate and approved drainage devices that are capable of carrying concentrated runoff. Current industry standards
