COVER SHEET

FLESHMAN CONSTRUCTION INSPECTORS

MESSAGE: A single item inspection was performed at 1226 Northwind Cir Bellingham, WA per request of the occupants that have been concerned with water intrusion to the underfloor areas and possible connections to indoor air quality inside the home. The inspection was performed following a rain event. The adjacent grounds surrounding the home were found to be heavily saturated including the water meter and irrigation junction boxes, the storm drain at the road did not appear overwhelmed. Significant amount of standing water observed at the under floor areas, more than what is considered to be a typical amount even after a period of heavy rainfall. This could be a high water table, spring or other condition that may not be feasible to correct. Strongly recommend further evaluation by a drainage professional and an indoor air quality professional.

1226 Northwind Cir Bellingham, WA

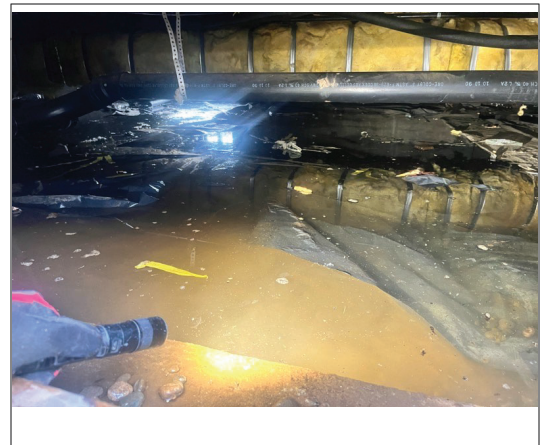
An excessive amount of standing water observed in the crawl space, as much as 15" deep near the access opening and covering all of the under floor areas from foundation to foundation. Means for removal of the water is needed. Consult a qualified Drainage Contractor and an Indoor Air Quality professional for further evaluation along with any all corrections as deemed necessary in a professional manner. Excessive Moisture: Any condition with the potential to enhance the moisture content of the wood, such as: obvious plumbing or roof leaks; bare moist soil; or standing and/or seasonal standing water in the crawl space.
